NASA Technical Memorandum 84552

FAILURE CHARACTERISTICS OF GRAPHITE-EPOXY STRUCTURAL COMPONENTS LOADED IN COMPRESSION

JAMES H. STARNES, JR. AND JERRY G. WILLIAMS

SEPTEMBER 1982

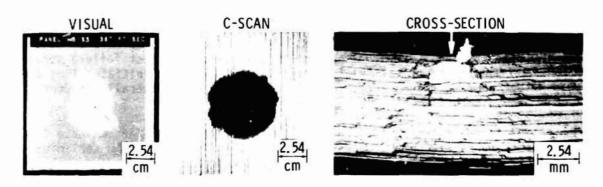
Physical characteristics of impact damage. To determine the characteristics of impact damage, specimens were impacted by low-speed projectiles and examined. The specimens were visually inspected for front- and back-surface damage and ultrasonically inspected for indications of interior damage. Some specimens were also cross sectioned through the impacted region and inspected microscopically for interior damage. Photographs of the back-surface damage and the ultrasonic C-scan data and a photomicrograph of a cross section through the impacted region of a typical 48-ply orthotropic T300/5208 specimen impacted at approximately 100 m/s are shown in Fig. 4. This impact event caused visually detectable back-surface damage and considerable interior damage to the laminate as shown in Fig. 4. Interior damage included delaminations between plies with different orientation as well as through-the-thickness matrix cracks. There was no perceptible front-surface damage at the impact site (indicated by the arrow in Fig. 4).

Fig. 4. Damage in a 48-ply T300/5208 orthotropic laminate following impact from a 1.27-cm-diameter aluminum sphere traveling at 100 m/s. Arrow indicates impact site.

Several response mechanisms are active in creating the local damage illustrated in Fig. 4. The specimen response sequence following impact is illustrated in Fig. 5 in the temporal order that the events occur. On contact, a transient compressive normal stress wave is initiated and propagates through the laminate. This compressive wave reflects from the back surface as a tension wave and may produce matrix damage. The v-shaped patterns shown in Figs. 4 and 5 are similar to the fracture pattern created by stress waves in homogeneous brittle plates that have been impulsively loaded on one surface. Local transient bending waves are initiated following several reflections of the transient normal waves. The local transient bending deflections of a typical 48-ply laminate impacted at 91 m/s were contained within a region with a radius of approximately 2 cm and had a maximum out-of-plane deflection of approximately 1 mm. Interlaminar stresses associated with the local bending may cause local damage or if damage is present, this local bending deflec-

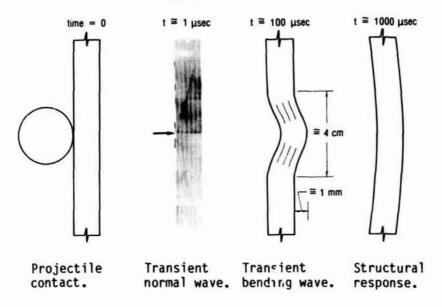
Fig. 5. Response of laminate following low-speed impact.

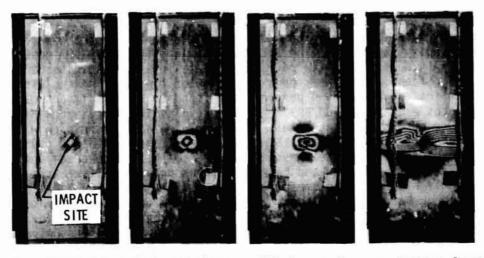
Delamination in an impact-damaged region of a laminate divides the laminate locally into a number f sublaminates. The local bending stiffnesses of the sublaminates are significantly lower than those of the original laminate and, as a result, a sublaminate may buckle at an applied strain that is significantly lower than the strain required to buckle or to fail the undamaged laminate. An example of local sublaminate buckling and subsequent delamination propagation that was observed during the residual-strength test of an impact-damaged laminate is shown by the moire-fringe pattern photographs in Fig. 6. The first photograph shows the local surface damage caused by impact and the succeeding photographs show the buckled sublaminate and the damage propagation across the specimen with increasing applied load. The amplitude of the sublaminate buckling mode grows with increasing applied load, and it is suspected that high values of stress are developed in the matrix at the delamination boundary. When the matrix stresses at the delamination boundary exceed the critical stress of the matrix, the buckled delamination grows in size until the matrix stresses at the delamination boundary are relieved. Additional loading eventually causes the buckled delamination to propagate completely across the laminate as shown in the right photograph. Analyses of this propagating delamination phenomenon have been developed by Chai, Babcock, and Knauss (1981) for beams and by Chai (1982) for plates. These analyses couple the effect of local buckling with a fracture mechanics-based energy release rate criterion. These analytical results are qualitatively consistent with the experimental observations shown in Fig. 6.

Fig. 6. Propagation of impact damage with increasing compressive load.

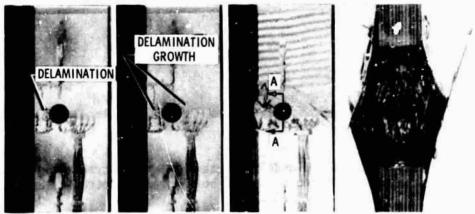
Failure characteristics of laminates with holes. A series of photographs of moire-fringe patterns that highlights the propagation of camage in the vicinity of a 1.91-cm-diameter hole in a T300/5208 laminate is shown in Fig. 13. The mointringe patterns represent local out-of-plane deformations that appear to be a delaminations. A cross section through the hole of the failed laminate is shown in the far right photograph in Fig. 13, and many delaminations and broken fibers are evident. For applied loads below 93 percent of the ultimate failure load of the laminate, there were no local failures indicated by the moire-fringe patterns.

Fig. 13. Propagation of local failures in a graphite-epoxy specimen with a 1.91-cm-diameter hole. Moire-fringe patterns indicate apparent delamination.

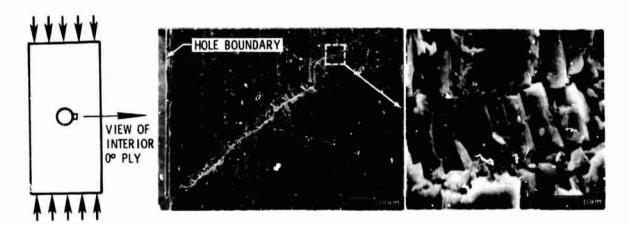
The similarities between the compressive strength reductions for unstitched T300/ 5208 laminates (delamination prone when impacted) and stitched T300/5208 and T300/ BP907 laminates (both delamination resistant when impacted) with holes (see Figs. 11 and 12) suggest the a local failure mechanism other than delamination may occur at applied loads below those corresponding to the visible local failures shown in Fig. 13. To determine if such a mechanism exists, a laminate specimen with a hole was loaded to less than the expected failure load; and then unloaded without any visible evidence of local failures. A small section was cut from the region adjacent to the hole where a high strain concentration exists. The outer fourteen plies were ground away to expose an interior 00 ply, and a scanning electron photomicrograph of this 00 ply is shown in Fig. 14. The pattern of broken fibers on the microscopic level suggests a shear crippling failure mode exists that may have been initiated by microbuckling of the graphite fibers. Apparently, the strain concentration at the edge of the hole is sufficiently large to cause local microbuckling of the 00 fibers, and the combination of bending and axial strains causes these fibers to fail in the shear crippling mode at applied loads below those corresponding to the visible local failures shown in Fig. 13. The loads that were supported by the broken fibers are subsequently redistributed to adjacent fibers away from the hole. For small holes (a/w < 0.2 for these specimens) the strain concentration near the hole decays to the average laminate strain within a small distance from the hole edge. As a result, the loads formerly supported by the broken fibers are redistributed to other fibers that are below the critical microbuckling strain and no additional fibers are broken until a higher load is applied. This load redistribution into a region of lower strains may provide some of the strain relief necessary to allow laminates to support loads greater than those corresponding to the notch-sensitive failure curve shown in Fig. 11. For large holes (a/w > 0.2) a larger region near the hole is highly strained and the loads from the broken fibers are redistributed to a highly strained region where additional fiber failures can occur without any additional applied load. This load redistribution into a highly strained region may explain why the failures of lam.nates with larger holes are likely to correspond to the failures predicted by the notch sensitive results in Fig. 11.

Fig. 14. Shear crippling failure mode initiated by fiber microbuckling in a high strain concentration region near a hole in an orthotropic laminate.

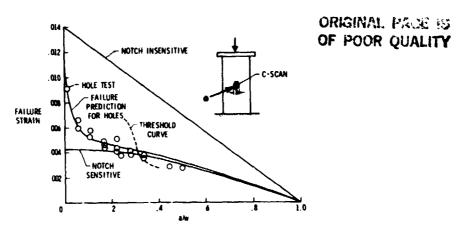
Comparison of effects of impact damage and holes. Both impact damage and circular holes have been shown to reduce the compressive strength of graphite-epoxy laminates. A comparison of the effects of impact damage and holes on failure strain is shown in Fig. 15 for a *300/5208 laminate. The open circles represent hole data for both stitched and unstitched laminates from Fig. 12. The dashed curve

Fig. 15. Comparison of failure strains of 48-ply T300/5208 orthotropic laminates with holes and impact damage. w = 11.4 cm.

represents impact data for unstitched T300/5208 laminates. To generate the dashed or impact curve, the failure strains from Fig. 3 were plotted as a function of an ultrasonically-determined damage width (Rhodes, Williams and Starnes, 1979) for the corresponding impact speed. By plotting the impact data in this manner, holes appear to reduce the compressive strength of these T300/5208 laminates more than impact damage when the a/w ratio is less than 0.3 and slightly less than impact damage when the a/w ratio is greater than 0.3.

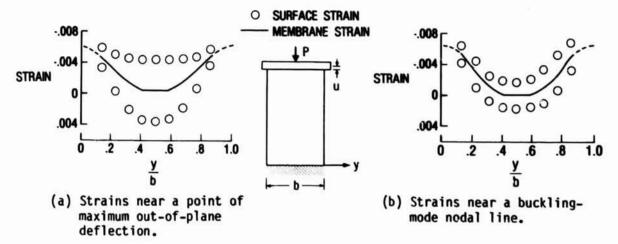
Longitudinal surface strain measurements just before failure from nine pairs of back-to-back strain gages distributed across a typical 16-ply specimen at two locations are shown in Fig. 18. The gage location y is normalized by the specimen width b. One row of strain gage pairs was located so the center pair would be near a point of maximum out-of-plane deflection, and the data for this row are shown in Fig. 18a. The other row of gages was located near a buckling-mode nodal line, and the data for this row are shown in Fig. 18b. The measured data are represented by the circles on the figure. The curves on the figure are the average of the strains for each pair of gages and represent the membrane strain. No gages were located at the specimen edges so an estimate of the membrane strains near the edges based on measured end shortening data is represented by the dashed parts of the curves. As expected, the data indicate that the bending strain is greatest in the specimen center near the point of maximum out-of-plane deflection and that the membrane strain is greatest near the specimen edges. A photograph of the moirefringe pattern representing the out-of-plane deflections of a typical 16-ply specimen just before failure is shown in Fig. 19a. Failure occurred across the specimen at a nodal line as indicated by the moire-fringe pattern shown in Fig. 19b. The failure mode appears to be a shear failure mode as shown in Fig. 19c. Apparently, the higher membrane strains near the specimen edges couple with the

Fig. 18. Longitudinal strain distributions across a laminate loaded to 3.26 times its buckling load.

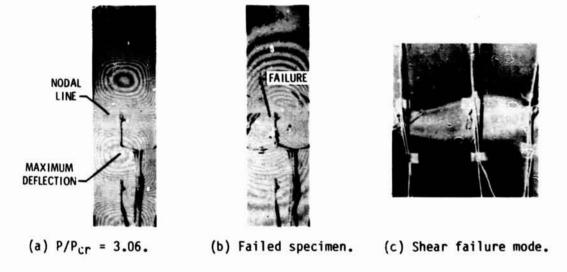
Fig. 19. Out-of-plane deflection patterns and failure mode of an unstiffened graphite-epoxy laminate with postbuckling strength.

out-of-plane deflection gradient at the nodal line to induce sufficient transverse shearing forces to fail the specimen in shear before the large bending strains at the points of maximum out-of-plane deflection become critical. All of the specimens represented by the data in Fig. 16 failed across the specimen at a nodal line.

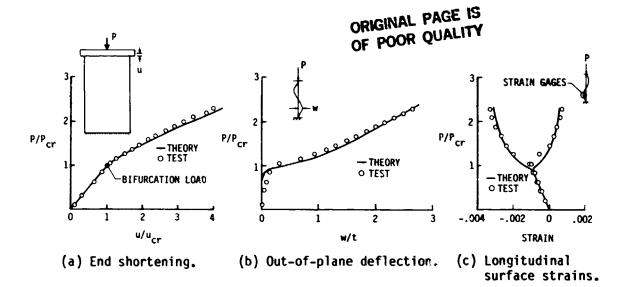
A comparison between test results and analytical results obtained with the STAGS analysis code (Almroth and Brogan, 1978) is shown in Fig. 20 for a typical 24-ply orthotropic specimen. End shortening u normalized by the end shortening at buckling $u_{\rm Cr}$ (Fig. 20a), out-of-plane deflection w at a point of maximum deflection normalized by the specimen thickness t (Fig. 20b), and the longitudinal surface strain at a point of maximum out-of-plane deflection (Fig. 20c) are shown as functions of the applied load P normalized by the buckling load $P_{\rm Cr}$. An initial geometric imperfection with the same shape as the buckling mode

Fig. 20. Comparison of experimental and analytical postbuckling results. t = specimen thickness.

was used in the nonlinear analysis. The amplitude of the initial imperfection was assumed to be small. The experimental and analytical results shown in the figure correlate well up to failure. A capability for reliably and accurately predicting failure is not yet available.

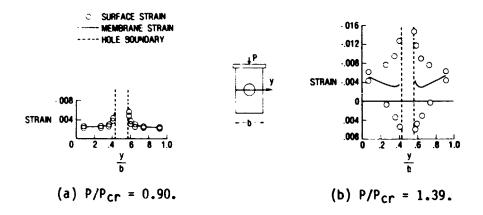
Fig. 21. Longitudinal strain gage data near a circular hole.

point of maximum out-of-plane deflection of the buckling mode and the strain distribution near the hole shown in Fig. 21b indicates that buckling causes a change in strains across the panel to include large local bending strain components at the edge of the hole and large membrane strains at the specimen edges.

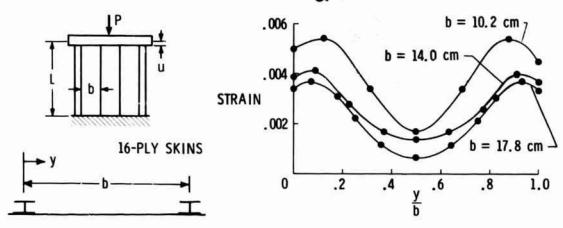
Fig. 27. Longitudinal membrane strain distribution across the skin between stiffeners of panels with 16-ply skins just before failure.

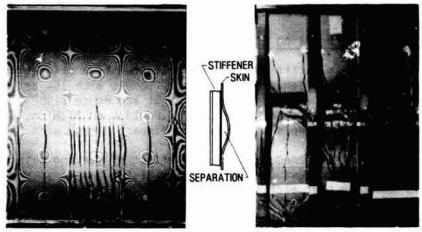
(a) Out-of-plane deflection pattern. (b) Rear view of failed panel.

Fig. 28. Out-of-plane deflection pattern and failure mode of a stiffened graphite-epoxy panel.

a typical failed specimen is shown in Fig. 28. Failure occurred when the skin and the stiffeners separated from one another in the interior of the panel as shown in Fig. 28b. Apparently, the large out-of-plane deflection gradients, represented by the moire-fringe pattern for the skin of a typical panel just before failure shown in Fig. 28a, couple with the large skin strains near the stiffeners (e.g., Fig. 27) to cause interlaminar failures to occur in the stiffener region.

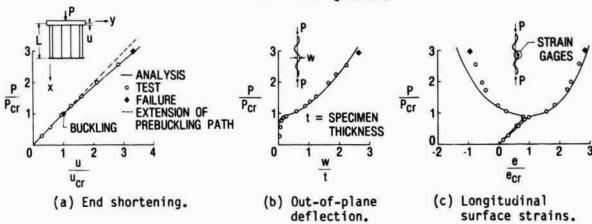
A comparison between test results and analytical results obtained with the STAGS analysis code is shown in Fig. 29 for a typical panel with a 16-ply quasi-isotropic skin and 17.8-cm stiffener spacing. Typical results for end shortening u normalized by the calculated end shortening at buckling $u_{\rm CT}$ (Fig. 29a), out-of-plane deflection w near a point of maximum out-of-plane deflection normalized by the skin thickness t (Fig. 29b), and surface strains e near a point of maximum out-of-plane deflection normalized by the calculated strain at buckling $e_{\rm CT}$ (Fig. 29c) are shown as a function of the applied load P normalized by the calculated buckling load $P_{\rm CT}$. The open circles represent test data and the curves represent analytical predictions. The results correlate well up to failure. A moire-fringe pattern corresponding to the out-of-plane deflections of the specimen just before failure is shown in Fig. 30a. A contour plot of the out-of-plane skin deflections determined by STAGS for the corresponding load is shown in Fig. 30b.

Fig. 29. Comparison of experimental and analytical postbuckling results. t = skin thickness.

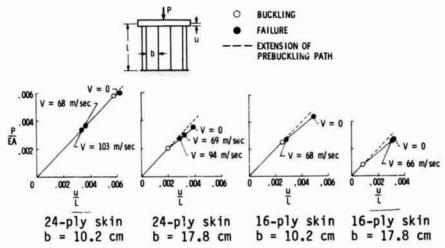
Effects of impact damage on postbuckling strength. The effects of low-speed impact damage on the postbuckling behavior of stiffened graphite-epoxy panels were studied by Starnes, Knight and Rouse (1982) by subjecting several panels to impact damage and then loading the panels to failure. Panels with 16- and 24-ply quasi-isotropic skins and four equally spaced stiffeners 10.2 cm or 17.8 cm apart were impacted at speeds ranging from 66 to 103 m/s. All panels were impacted in the skin at a stiffener attachment flange and some panels were also impacted in the skin midway between two stiffeners. There was some visually detectable damage in all cases. The effects of impact damage on the postbuckling behavior of the panels are shown in Fig. 31. Initial buckling is indicated by the open circles on the figures, and specimen failure is indicated by the filled circles. Data for panels with no impact damage (V = 0) are shown for comparison. These results indicate

Fig. 31. Effect of low-speed impact damage on the postbuckling response of stiffened panels with quasi-isotropic skins. b = stiffener spacing.

that impact damage can degrade the postbuckling strength of stiffened panels. The damaged panel with 24-ply skins and 10.2-cm stiffener spacing failed before buck-ling; all other damaged panels failed after buckling. All damaged panels failed as a result of the impact damage inflicted in the skin at a stiffener attachment flange. The front view of a panel with a 24-ply skin and 10.2-cm stiffener spacing with two damage sites is shown just before failure in Fig. 32a. The local impact damaged regions are indicated in the moire-fringe patterns. The damage in the skin midway between stiffeners (upper right impact site in Fig. 32a) has propagated across the skin bay to the adjacent stiffeners and arrested. The damage in the skin at the stiffener attachment flange (lower left impact site) is contained in the stiffener region. A rear view of this panel after failure is shown in Fig. 32b and indicates that the damage at the stiffener attachment flange initiated failure of the panel rather than the more visually detectable damage midway between the stiffeners. It appears that damage near a stiffener attachment flange can reduce postbuckling strength more than damage in the skin midway between stiffeners. The results shown in Fig. 31 indicate that panels with higher buckling strains appear to be affected more by impact damage than panels with lower buckling strains.

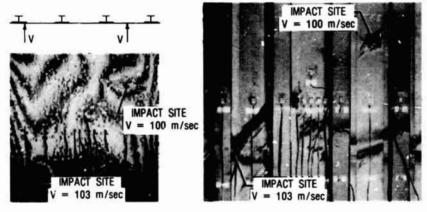
(a) Moire-fringe pattern just before failure.

(b) Rear view of failed panel

Fig. 32. Impact damaged panel with a 24-ply skin and a 10.2-cm stiffener spacing.
